# In situ Geothermal Laboratory

#### **EGS Gross Schoenebeck**

# Well design concepts for deep geothermal wells

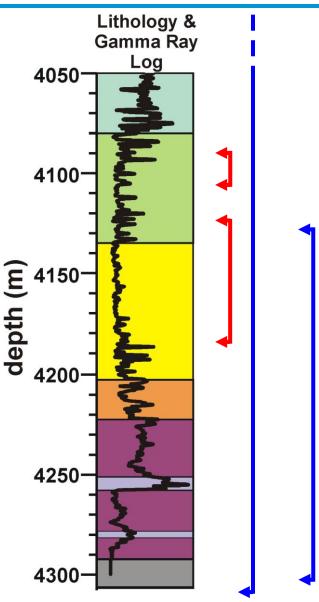
# **Operations overview**

#### open hole proppant frac

#### Jan/Feb 2002

- production test / logging
- 4130-4190m (frac 1)
- 4080-4118m (frac 2)
- production test / logging

# open hole waterfrac start Jan/Feb 2003

- 3874-4294m, borehole instability
- production test

#### cont. Nov/Dec 2003

- 4135-4309m
- production test / logging

#### **Dec 2004**

injection test

#### April 2006 to Jan 2007

O drilling 2. well

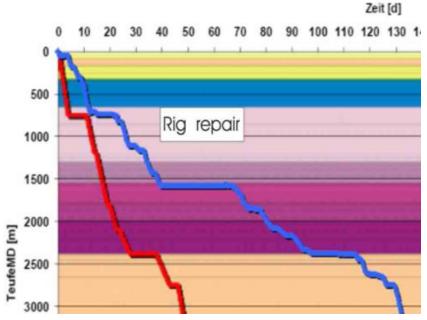
#### Large top hole diameter affected ROP

Insufficient pumping capacity in the top hole region (23") lead to bit balling resulting in a ROP of 4...7 m/h and an increased number of trips.

Improper bit selection reduced ROP in

the mesozoic section (16").

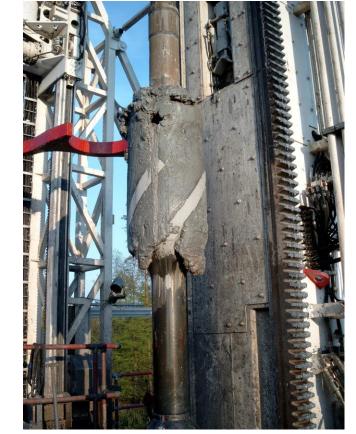
### disastrous cementation of 16"x13 3/8" casing

Total fluid loss occured during the cementation of the combined casing 16" x 13 3/8" despite of a slurry density of 1450 kg/m³ (Litefil by Schlumberger) due to plugging of the annulus by debris

temperature logs

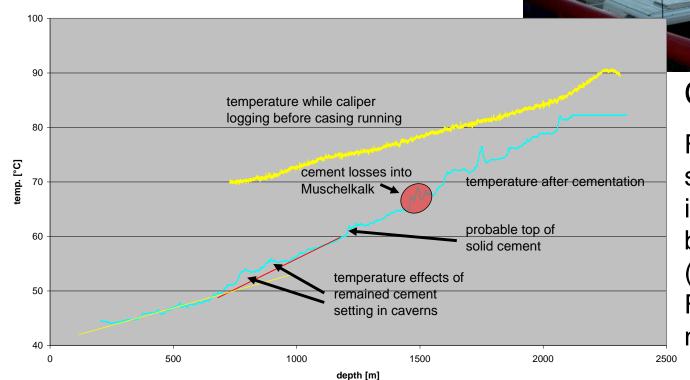
#### Conclusion:

Free pipe will not stand the thermally induced stresses to be expected (buckling). Free floating pipe is not acceptable.

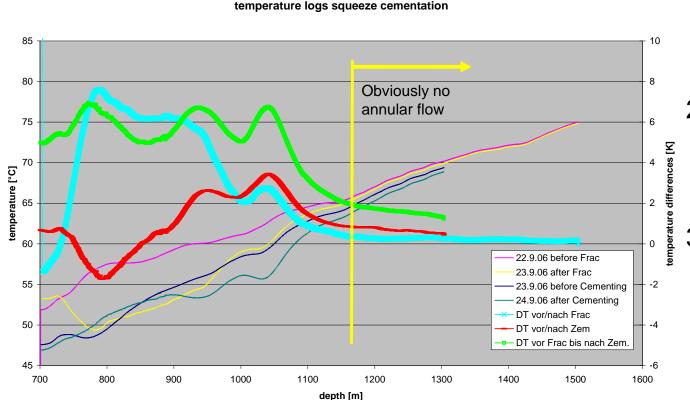
## Recovery of casing cementation

To prevent casing damage in the future of the production well a reverse squeeze cementation through the annulus was designed and successfully performed:

- 1. Free point
  estimation and
  cement bond
  log verified top
  of cement
  - Fluid loss
    during injection
    occurs near to
    top of cement
    Slurry density
    of squeeze
    cement with
    1,30 below
    density of mud

to be displaced

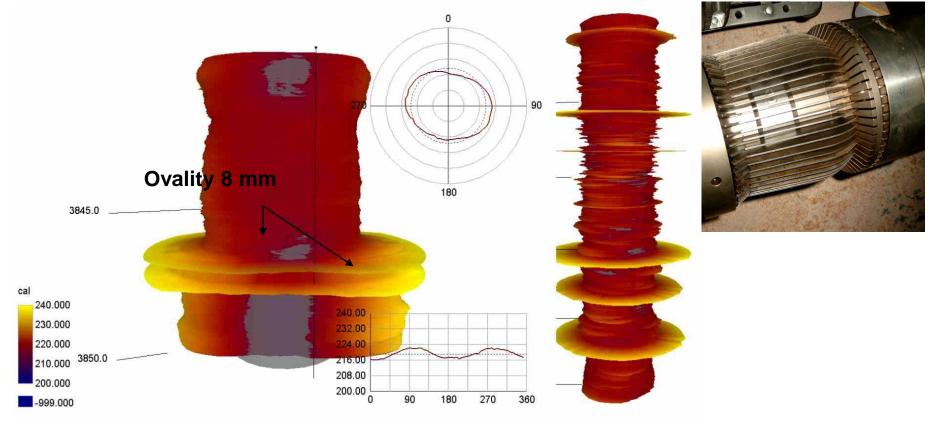
# Casing collapse within the rock salt

9 5/8" liner collapsed during drilling into the target formation after reduction of mud density from 2000 kg/m³ to 1060 kg/m³ (Heavy deformation between 3880...3200 m)

- Casing design according to the rules with an overburden pressure gradient of 2,3
- Casing material successfully inspected
- Anisotropic tension due to well path geometry unlikely according to cross-correlation
- Anisotropic tension due to rock salt inhomogenities within the salt dome in connection with the geomechanical impact of drilling not verifiable
- Anisotropic tension due to improper cementation of the deviated well not very probable due to no. and positioning of centralizers and cementing procedure strictly following the simulation

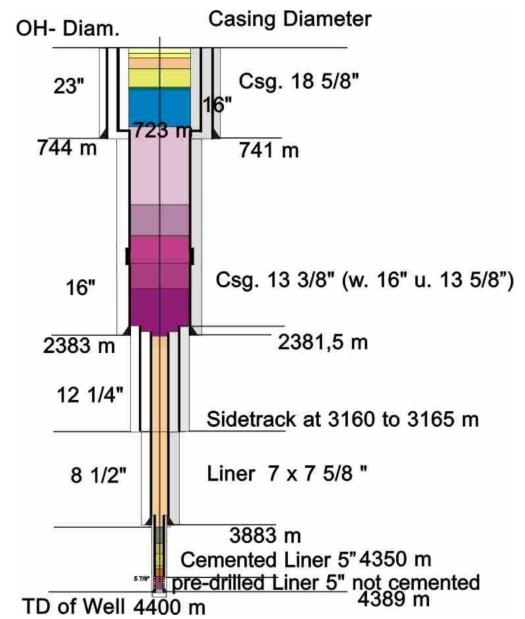
## Remedy for the collaps

The loss of one casing dimension forced to adjust the borehole design drilling of the Rotliegend section with 5 7/8" and running and cementing of an combined 5" liner with an uncemented section of preperforated pipes on bottom.
