Corrosion Study in Geothermal Wells - Soultz Study

Jiri Muller, K. Bilkova, M. Seiersten

Institute for Energy Technology

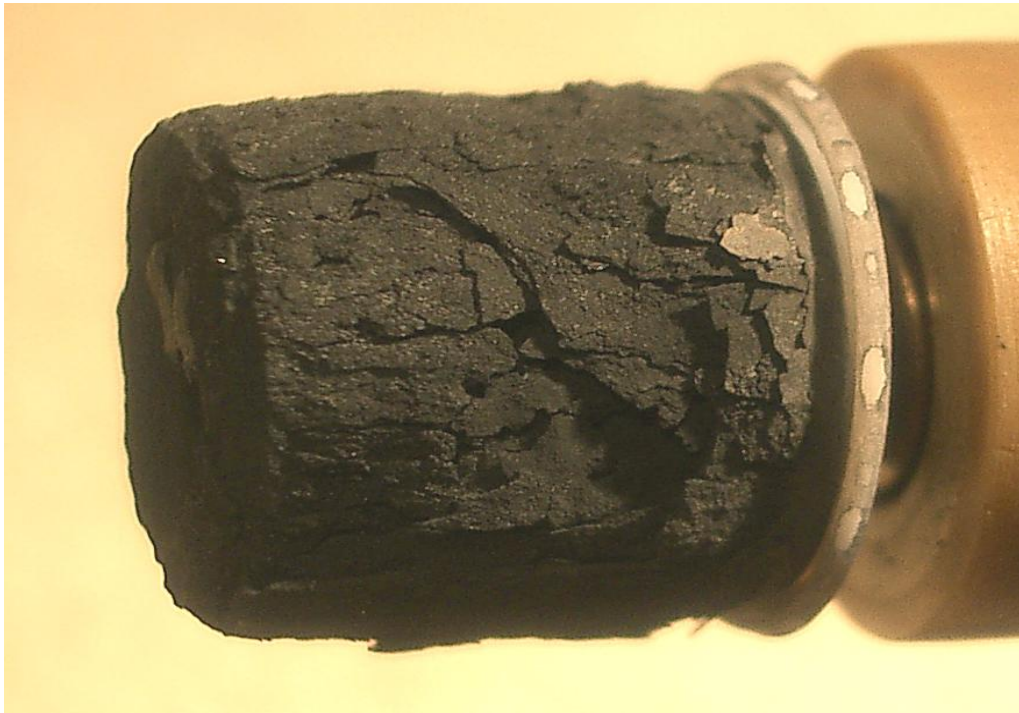
Carbon steel exposed for 10 days in non-alkaline brine with 0.02 m CO₂ at 200 °C

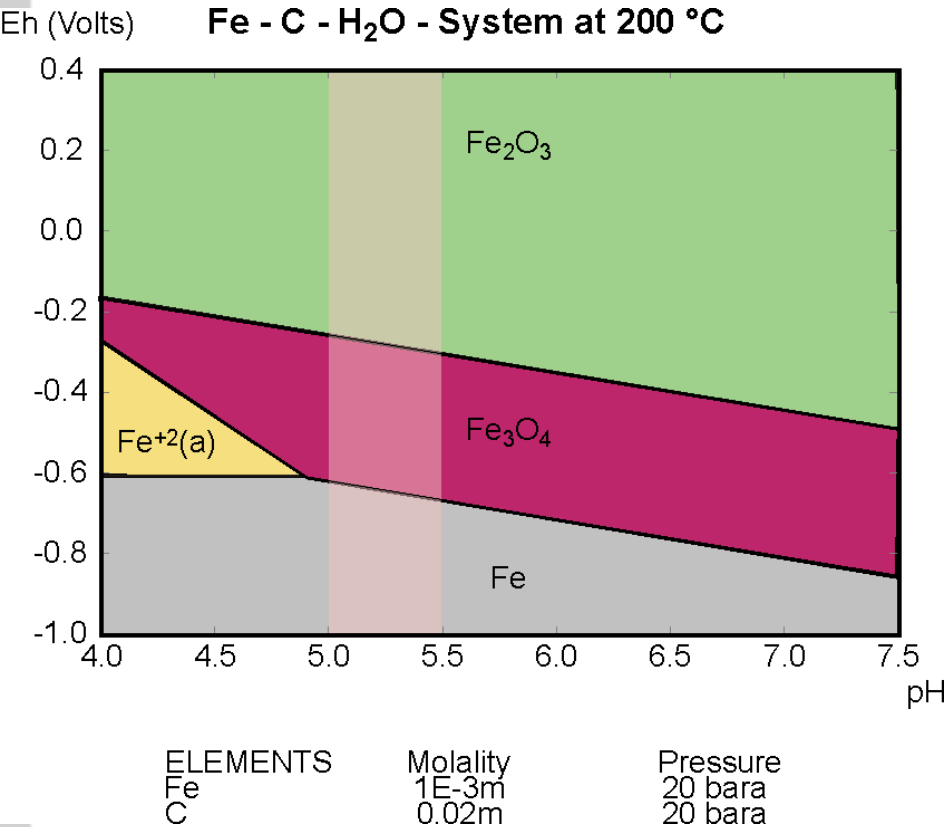
Fe stability diagram gives the stability of the iron phases at the Soult-sous-Forêts conditions.

Solid Fe₃O₄ phase could form at 200 °C, while dissolved iron is expected at 120 °C at the pH in the production wells.

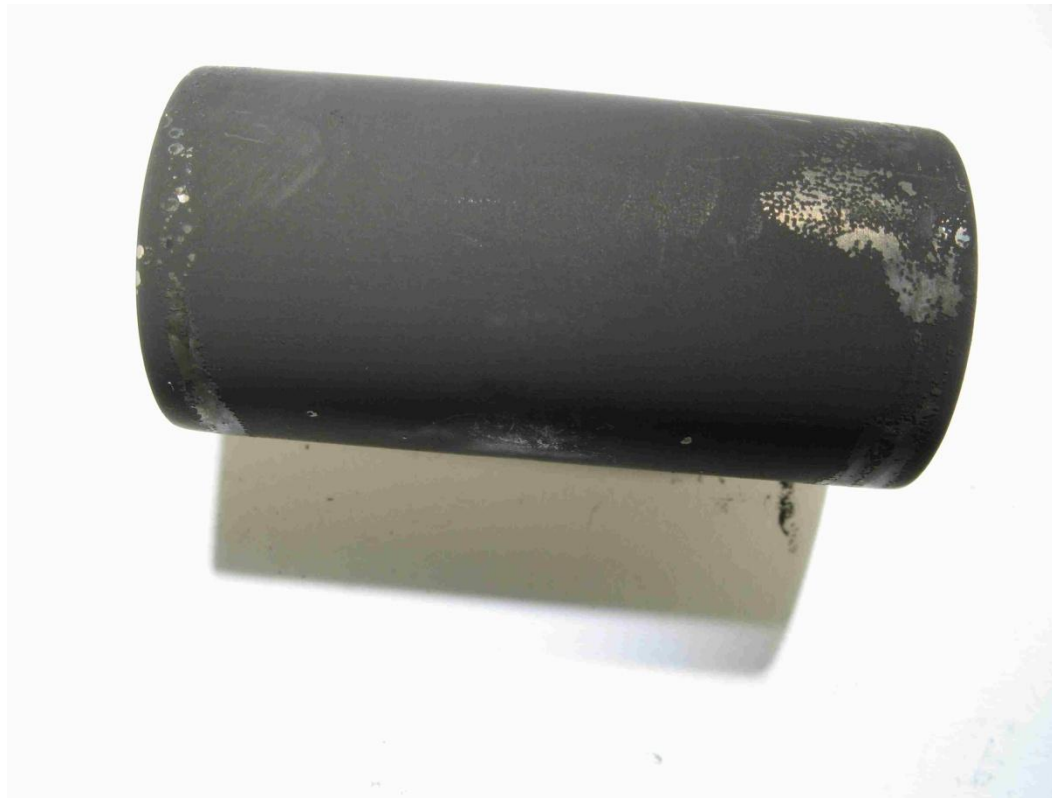
The carbon steel specimen was covered with black corrosion products after the test.

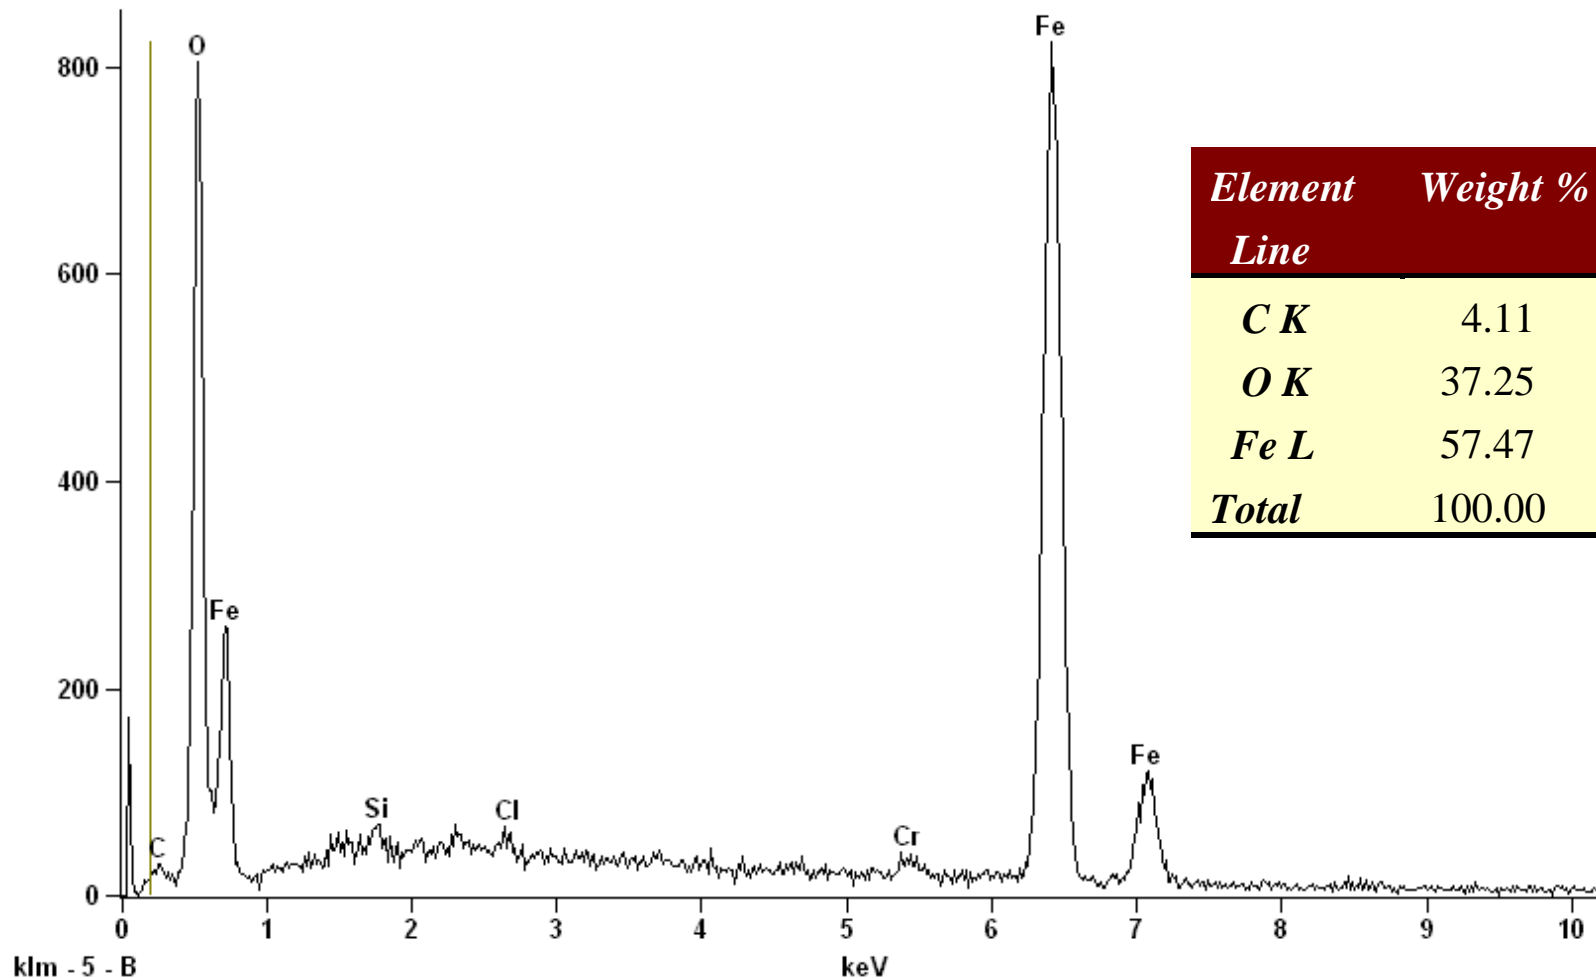
EDS analysis indicated that corrosion product layer was probably a hydrated iron oxide.

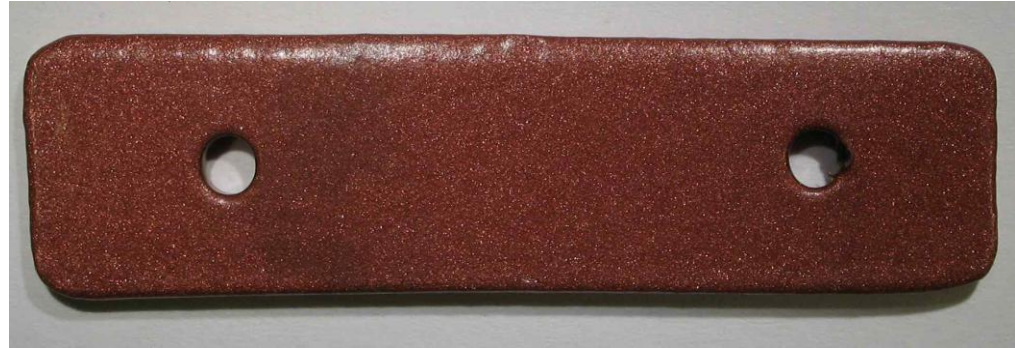
The red Teflon coating did not deteriorate during the test.

Photograph of the specimen with the red Teflon coating

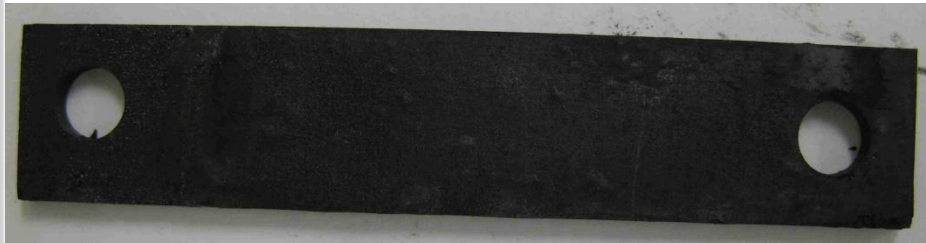
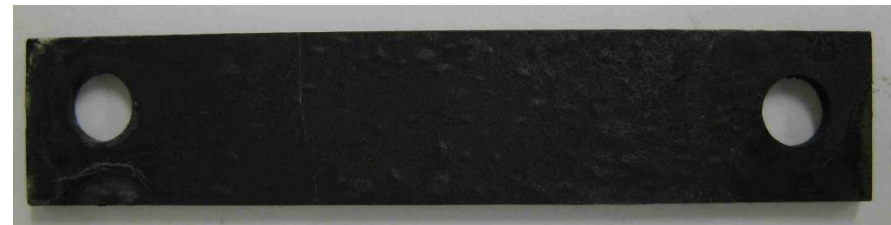
Surface of all the tested steels was covered with a corrosion product film.

TU42BT steel →

← P110 steel

N80 steel →
