Challenges faced in drilling high-temperature geothermal wells in Iceland

Sverrir Thorhallsson Iceland GeoSurvey July 3, 2007

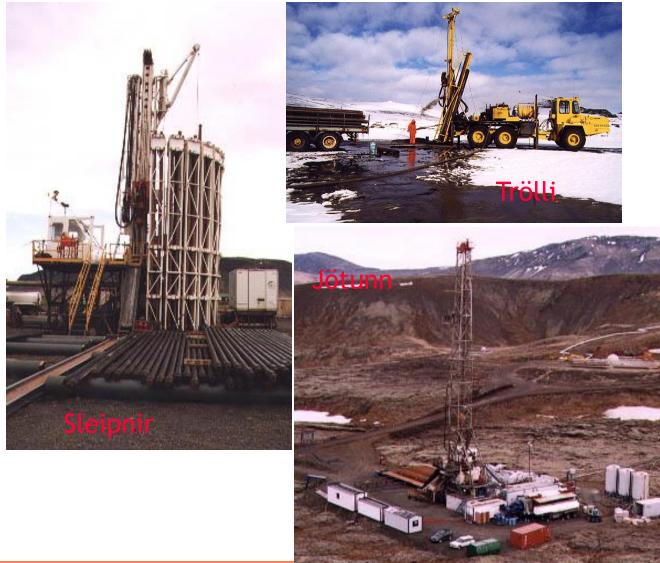
Drilling rigs in Iceland 2007

Óðinn JB	4000 m						
Geysir JB	4000 m						
Jötunn JB	3300 m						
Sleipnir JB	2400 m						
RFS new	1600 m						
Saga JB	1350 m						
Trölli RFS	1100 m						
Ýmir JB	1000 m						
Langþr. RFS 600 m							
Glámur RFS 600 m							
Einráður RI	F S 5 00 m						
Hrímnir JB	300 m						
Alvarr	300 m						
Trítill RFS	120 m

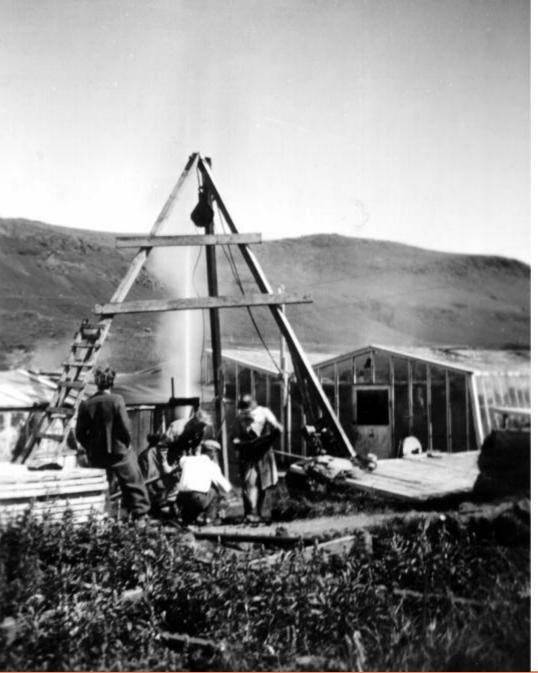
1940

43 HT wells were drilled to less than 250 m from 1940-1958 at: Hveragerði Krýsuvík Hengill Námaskarð After the arrival of "Gufubors" (The Steam Rig) in 1958 HT deep drilling started.

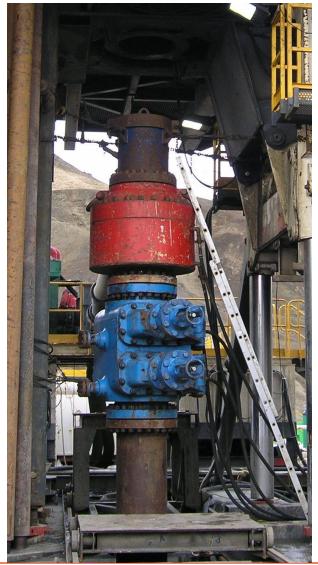
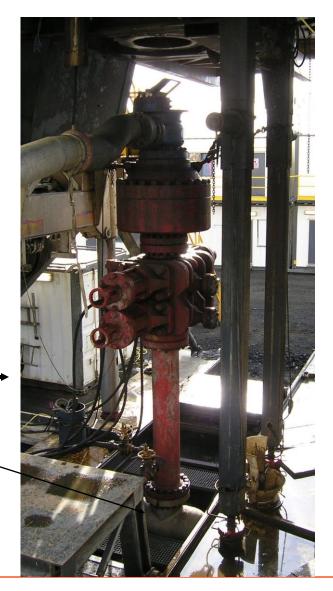
BOP stack

Drilling for -production casing.

Drilling production interval. Master valve on well.

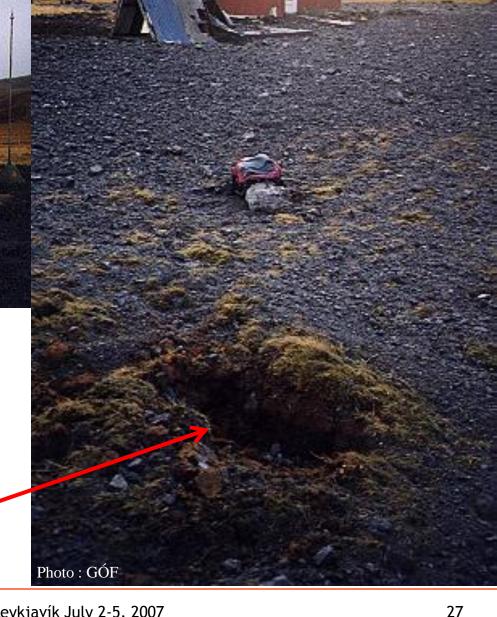
Krýsuvík Steam eruption of 1999

Krýsuvík steam eruption 1999 Rocks and mud thrown 300 m

> Hole where flying rock came down

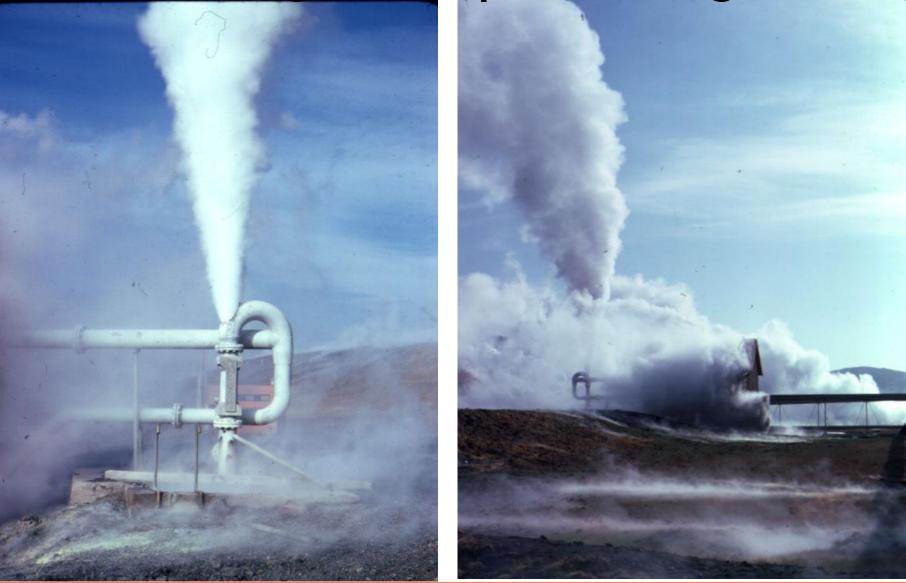
Bjarnaflag after producing lava

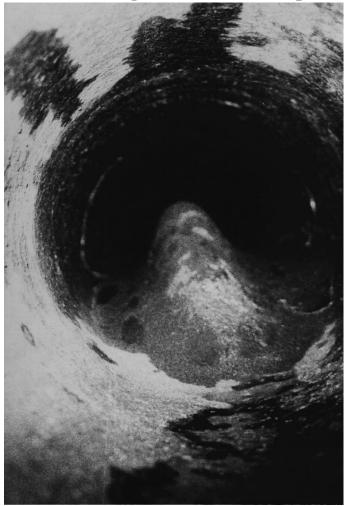
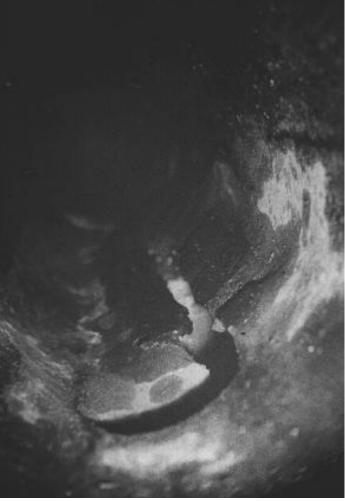
Casing collapse - trapped water

A casing collapse in 9 5/8" prod. cas. at 73.5 m depth in well SG-5. It was removed with a drop-chisel and the well used for another 5 yrs.

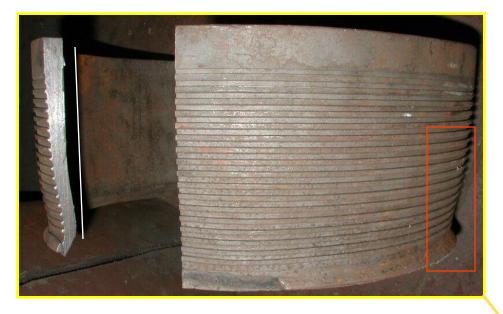
Failed connection

Buckling of a threaded casing joint.

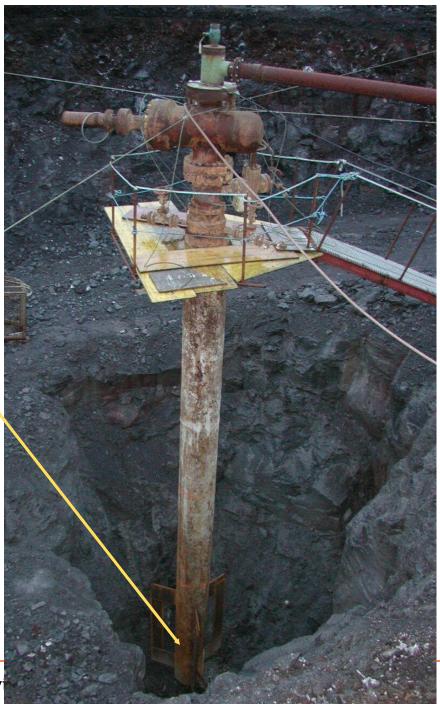
Excavation to replace the top 11 m of casing to the first coupling.
