Experiences on Geothermal Drilling in El Salvador

Manuel Monterrosa and Herbert Mayorga

Julio de 2007

Reykjavik, ENGINE WP 4

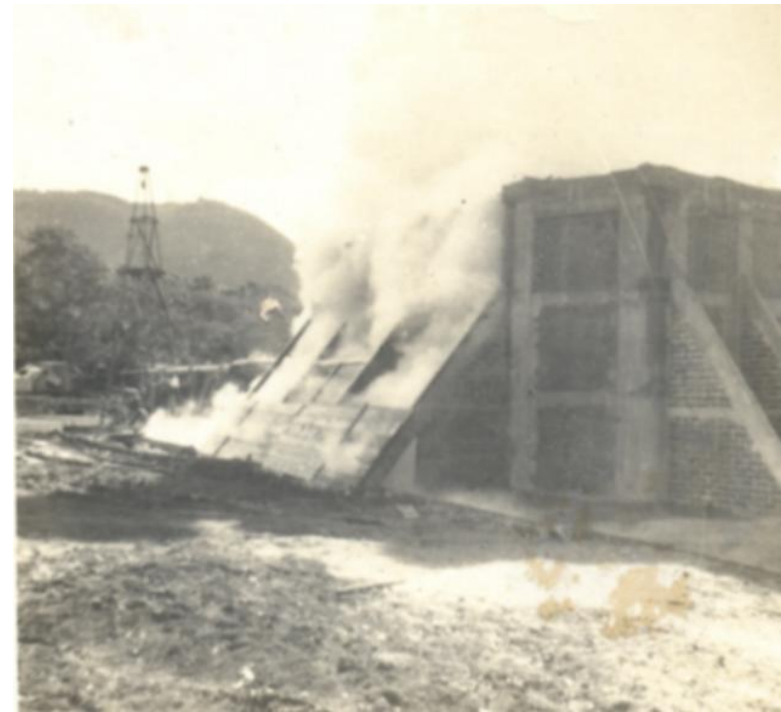
Discharge
Test AH-1

- The well AH-1 was the first well drilled in El Salvador by Loffland Brothers during 1968
- The discharge test of well AH-1 was the kick off point for the geothermal development in El Salvador. This well is still connected to the power plant.
- Since AH-1, over 100 wells have been drilled in El Salvador contributing to the geothermal development

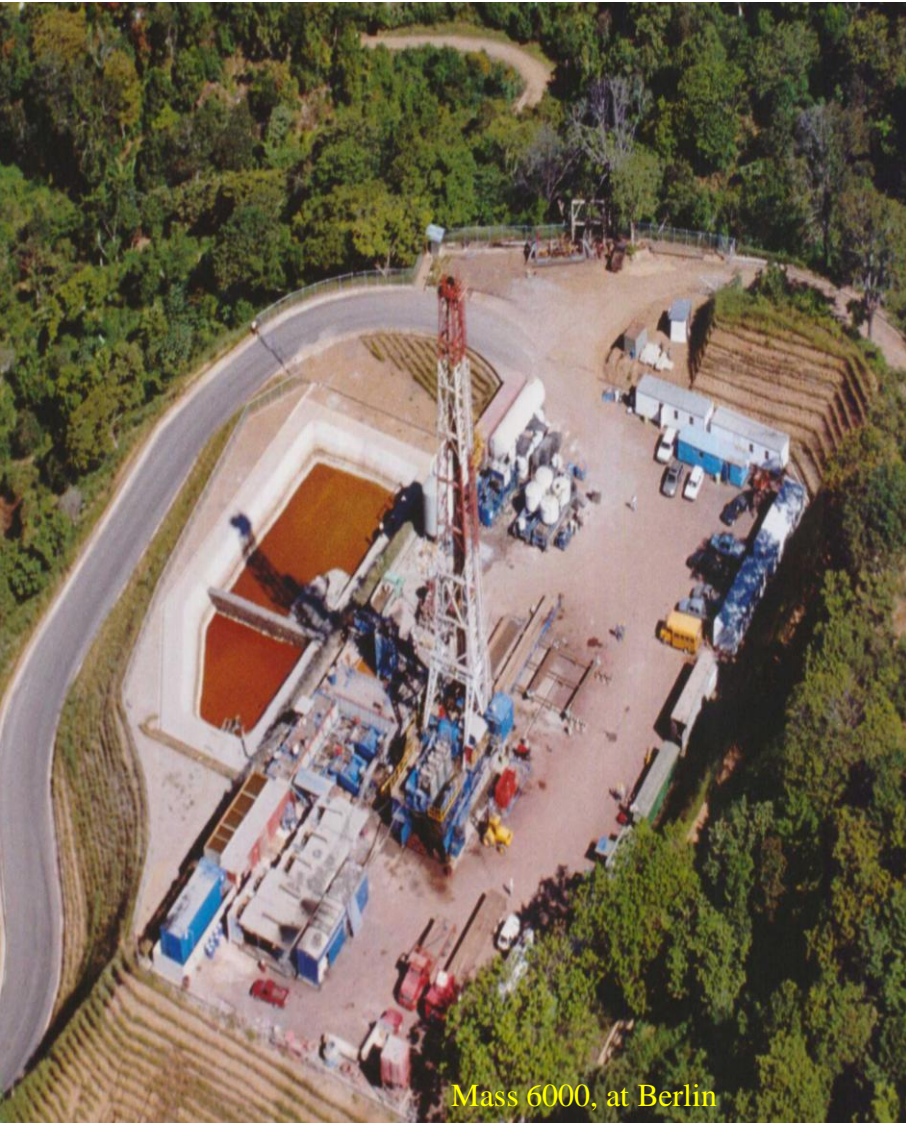
Mass 6000, at Berlin

<i>Rig</i>	<i>Draw Work Horsepower</i>	<i>Static Capacity Ton.</i>	<i>Gross Capacity Ton.</i>	<i>Structure Capacity Ton.</i>
<i>Mass 6000</i>	1200	250	350	300
<i>Mass 4000</i>	1100	250	340	328
<i>Ideco H-525</i>	650	160	250	300

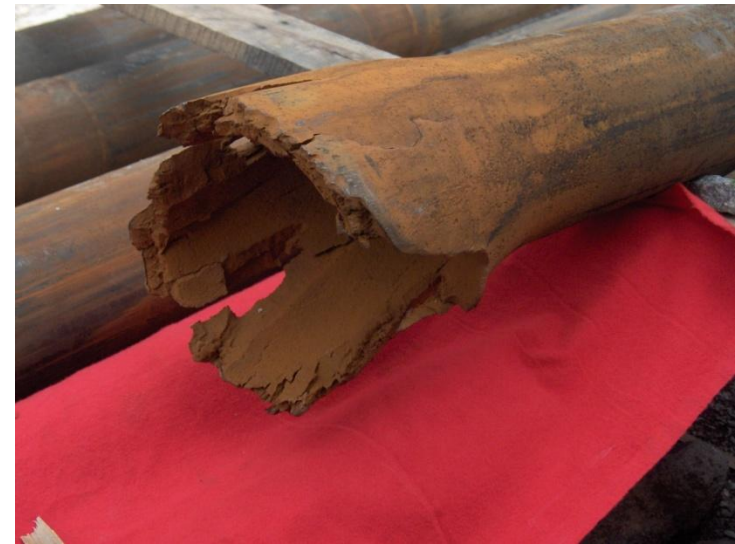
The blow out condition is happenig when steam are coming from the hole in unexpected way, in this case

- Use BOP is mandatory, BOP must be in good condition (tested)
- Good emergency procedures and personal trained for it.
- Survey equipment and drilling crew alert to those conditions.

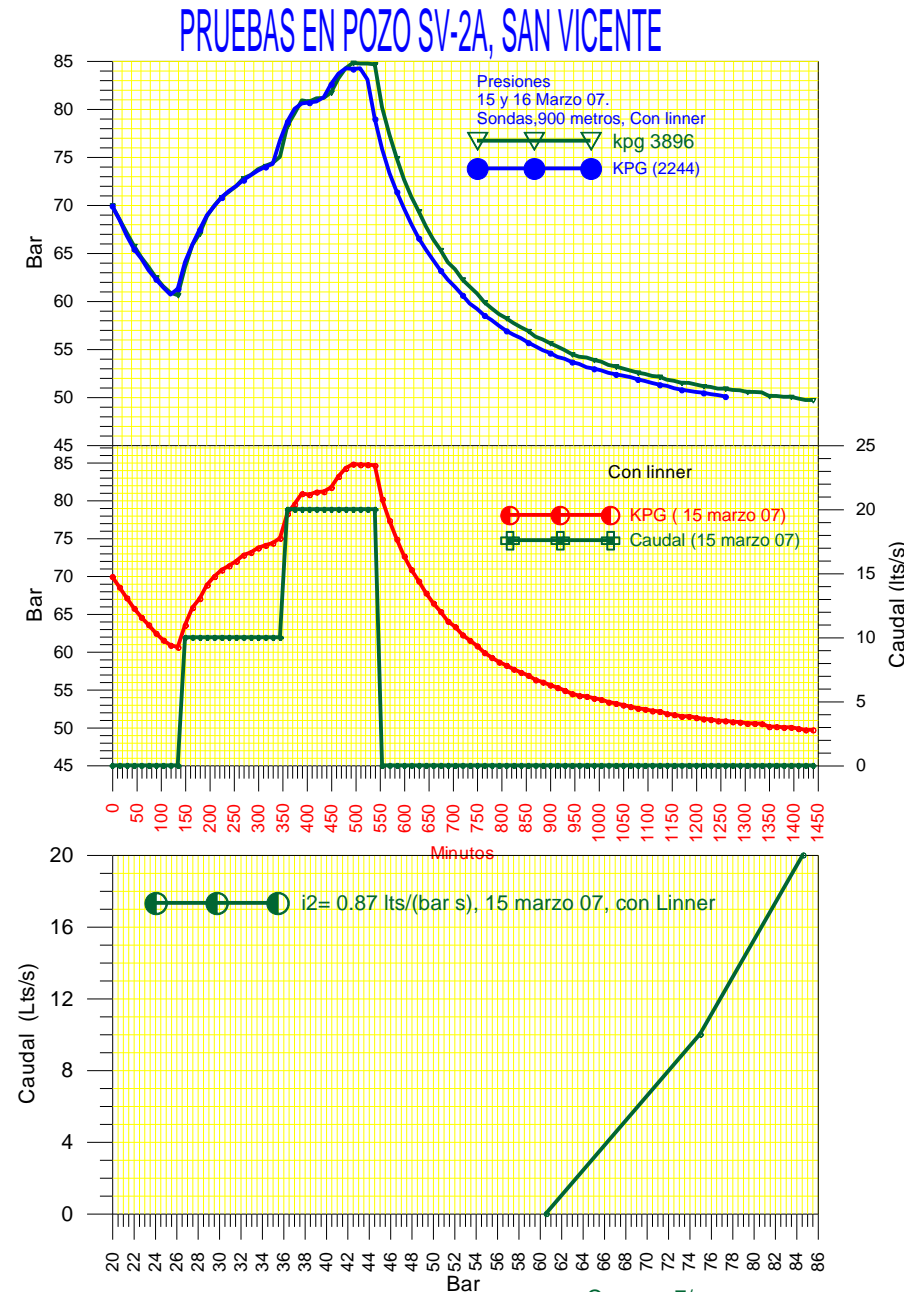
- During drilling operation the well testing are:
 - Calipers, hole diameters
 - MWD (Measurement While Drilling) for directional data
 - CET/CBL cement bond logging
 - Water level and loss circulation data
 - Injectivity tests into the target zone
 - If available geophysical logging

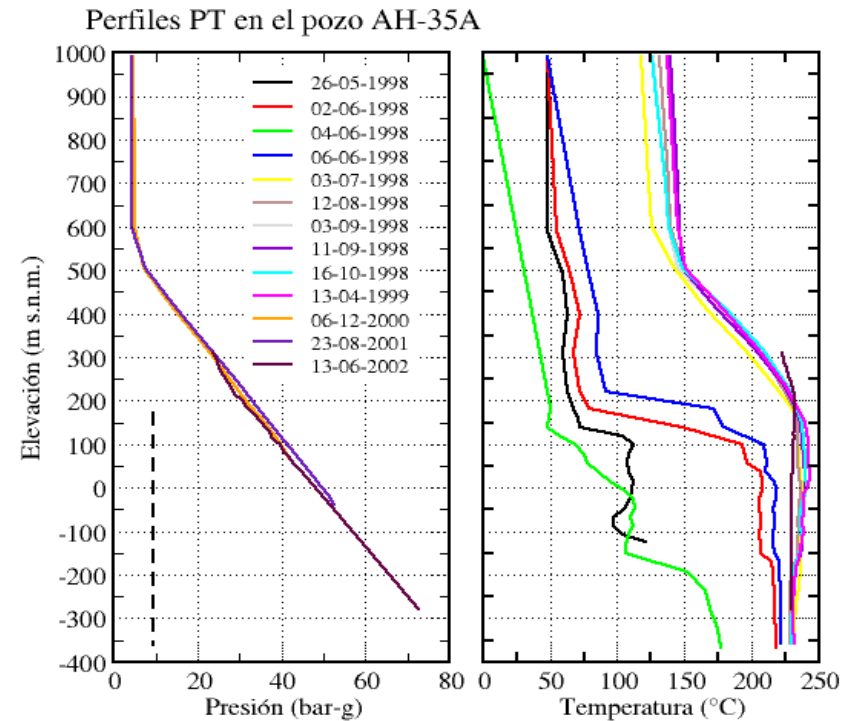
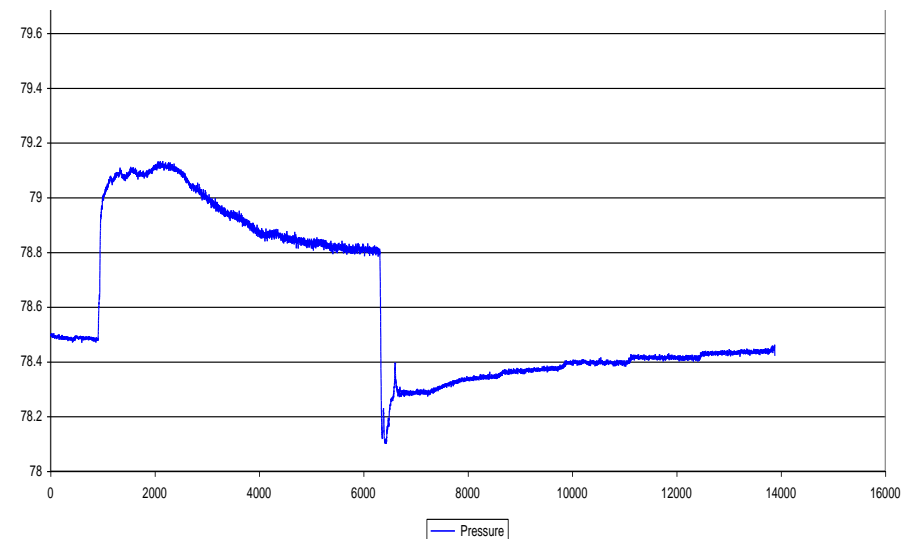
- When the drilling is finish and the target have been reached, at least the next tests could be done:
 - Final injectivity test
 - Warm up test including water level changes
 - Discharge test, when the thermodynamic condition indicate flowing conditions
